5A_AJHS

CJH • Stacks • Level_5 • A-side
Center for Jewish History

2018-10-01 to 2018-12-30
2 months, 30 days

Preservation Environment Evaluation

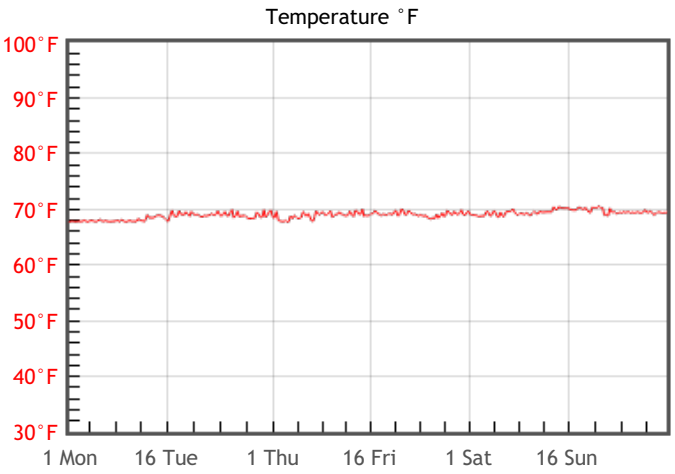
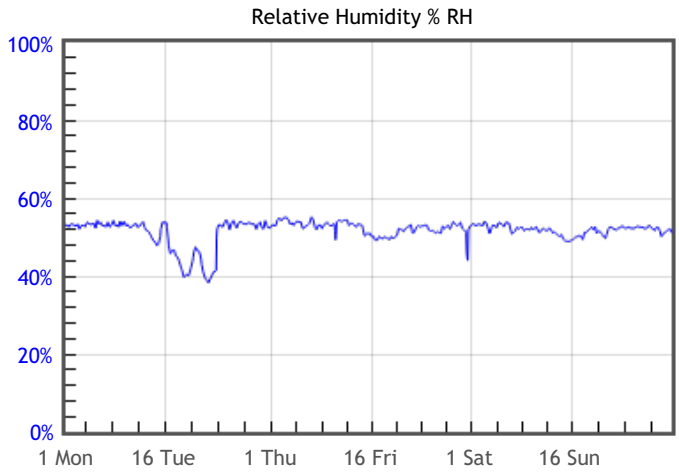
Graphs

Type of Decay	Risks & Metrics	Evaluation & General Comments
Natural Aging Chemical decay of organic materials	RISK TWPI = 38	Accelerated rate of chemical decay in all organic materials due to the cumulative effects of temperature and humidity, with especially high risk for fast decaying organic materials such as acidic paper, color photographs and cellulosic plastics.
Mechanical Damage Physical damage to hygroscopic materials	GOOD % DC = 0.14 % EMC min = 9.2 % EMC max = 9.8	Minimal risk of physical damage to most hygroscopic materials such as paintings, rare books and furniture.
Mold Risk Mold growth in area or on collection objects	GOOD MRF = 0	Minimal risk of mold growth.
Metal Corrosion Corrosion of metal components or objects	OK % EMC max = 9.8	Generally OK, but archeological or salt-encrusted metals may corrode due to extended periods of moderately high levels of humidity.
